Manhole Inspection Summary

Manhole # S09MM_011MH

Insp Date: **8/20/07 5:14 PM**

Location Address: **3208 ELGIN AVE**

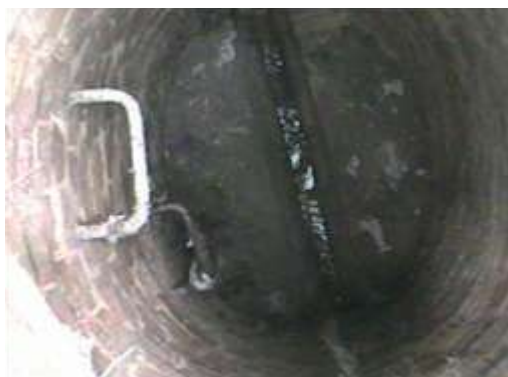
Defect 3

Steps Count: **3** Missing: **0** ☒ **Corroded**

CORRODED STEPS

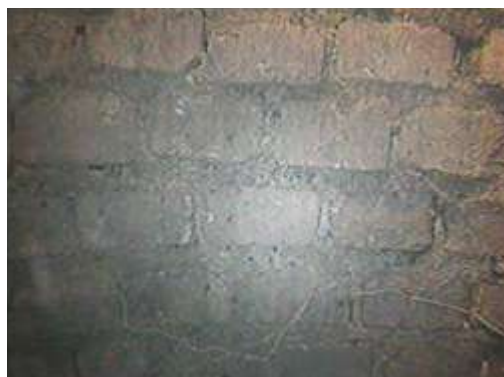
Defect 2

Condition: ☐ Sound ☐ Cracked ☒ **Root Intrusion** ☐ Loose Brick ☐ Deteriorated

Infiltration: ☐ None ☐ Joint ☐ Cracks ☐ Mortar ☒ **Roots** ☐ Wall

ROOT INTRUSION ON BARREL WALL

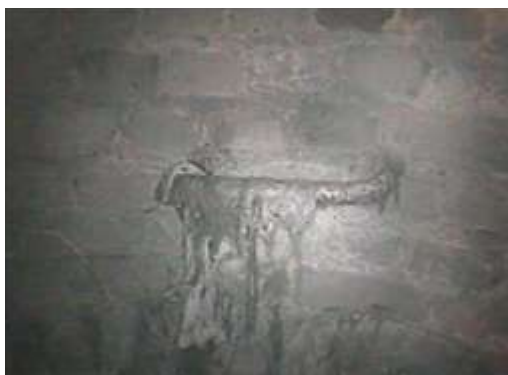
Defect 1

Surcharge ☒ **Evidence Of Surcharge** Depth: **4** (ft.) ☐ Active Surcharge Present

SURCHARGE

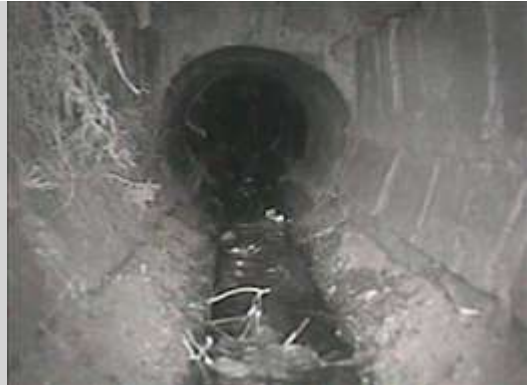
12 O'Clock Outflow

DEBRIS ON BENCH

Infiltration: **None** Pipe Seal Cond: **Roots**

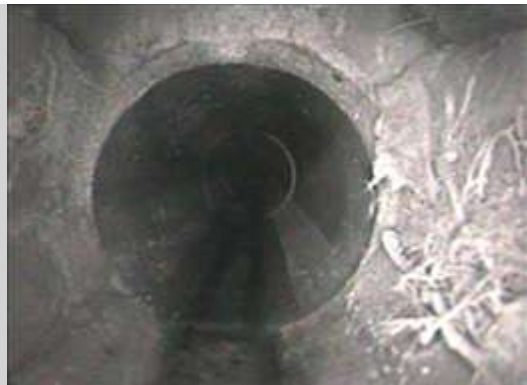
6 O'Clock Inflow

Infiltration: **None** Pipe Seal Cond: **Roots**
